## Case 418 : Narrative

Case Vehicle (A): 2000 Ford	Vehicle (B): 1993 Volvo
Type: Contour SE, 4-door sedan	Type: 850 GLT, 4-door sedan
Driver: 29-year-old male	Driver: 16-year-old male
CDC: 12-FDEW-1	CDC: 99-0000-0

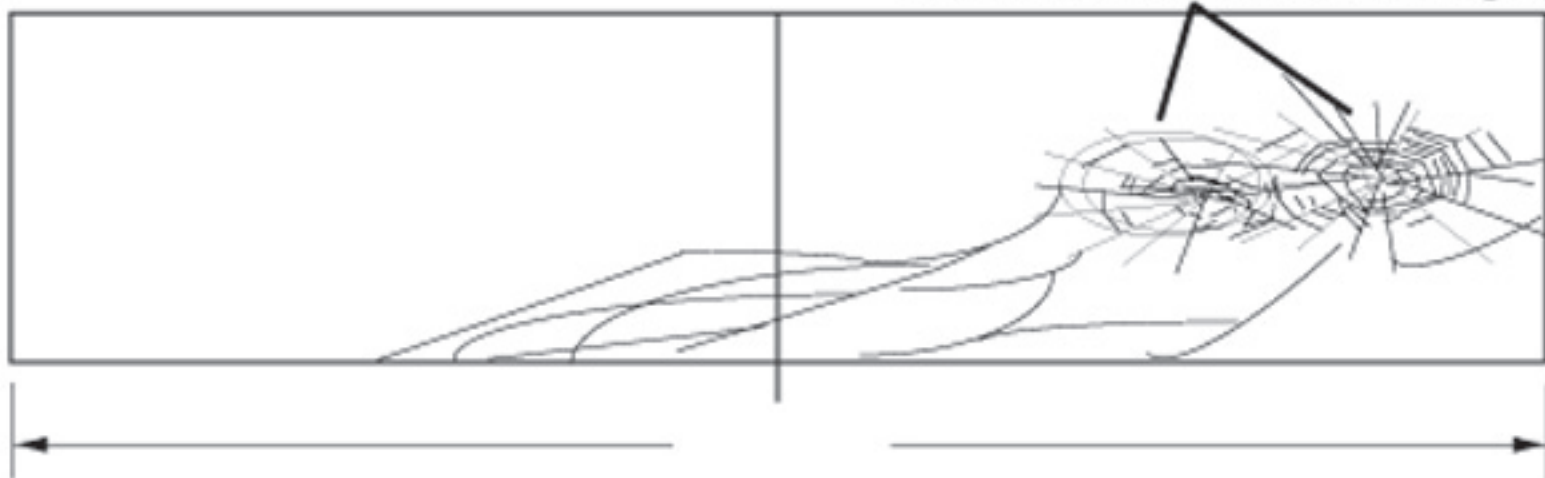
**Dash-mounted module cover damage**

[48 49](#) There was no damage to any components in the center-front area. [50 51](#) In the right-front seating area, there were three spider-web cracks in the windshield due to contact by the dash-mounted airbag cover, [52 53 54](#) but there was no other damage and there were no intrusions of vehicle interior components.

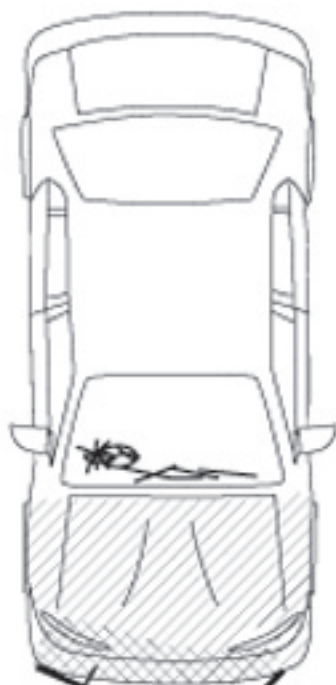
5 cm  
Max crush

133 cm  
Direct damage  
length
